# Explosion Risk Reduction (Construction Additives)

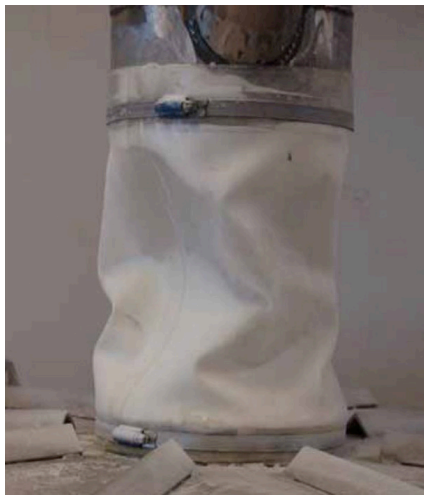
BEFORE

Fine, abrasive powders, combined with a pneumatic conveying system, meant that even small tears or gaps in the traditional clamped flexible connectors at the plant caused dust leakage.

The hose-clamp seals did not perform well under pressure, and with 25 different fittings, manual error with installing the existing clamp & hose connectors to the incorrect length also added to the leakage problems.

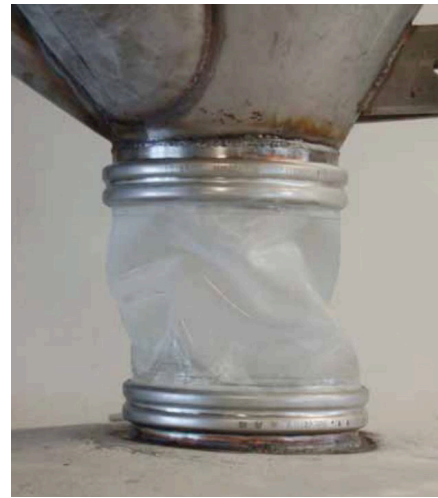
AFTER

After an initial trial BFM® fitting system was installed in the most challenging position on the sifter, the seal was so superior that AkzoNobel are now replacing all 25 flexible connectors with BFM® fitting. There is no longer dust leaking into the plant, and this has significantly reduced the risk of explosion.

As the connectors are replaced, the pipes and spigots are being adjusted to standardise the sizes, helping to reduce the inventory and multiple suppliers.

Replacement is also now fast and easy with no possibility of incorrect installation.
